# Manhole Inspection Summary

Manhole # S43M\_\_021MH

Insp Date: **6/5/08 11:14 AM**

**Location** Address: **805 caroline st**

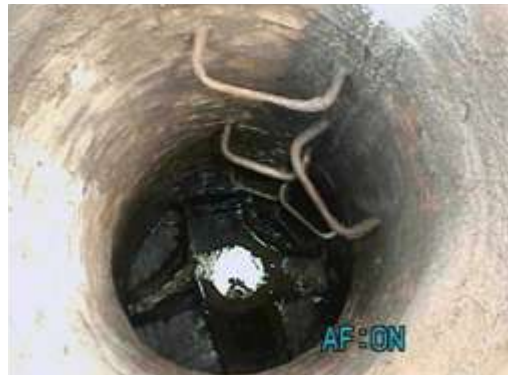
Defect 2

Infiltration: ☐ None ☐ Joint ☐ Cracks ☐ Mortar ☐ Roots ☒ **Wall**

Count: **6** Missing: **0** ☒ **Corroded**

☒ **Evidence Of Surcharge** Depth: **4** (ft.) ☐ Active Surcharge Present

steps, surcharge evidence, signs of infiltration on barrel & corbel wall

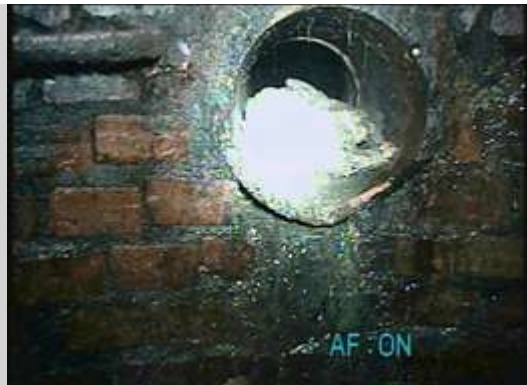
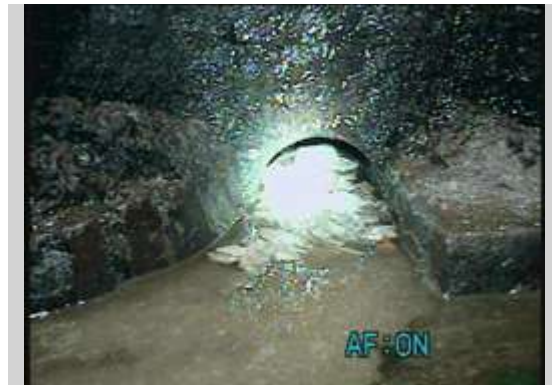
3 O'Clock Inflow

Deposits: ☐ None ☐ Mud ☐ Sludge ☒ Debris ☐ Grease

Silt Depth: 5 (in.) Deposits Extent: Heavy

Drop: Inside Direct
